NASA STUDENT LAUNCH

Flight Readiness Review Addendum

University of South Florida

Society of Aeronautics and Rocketry

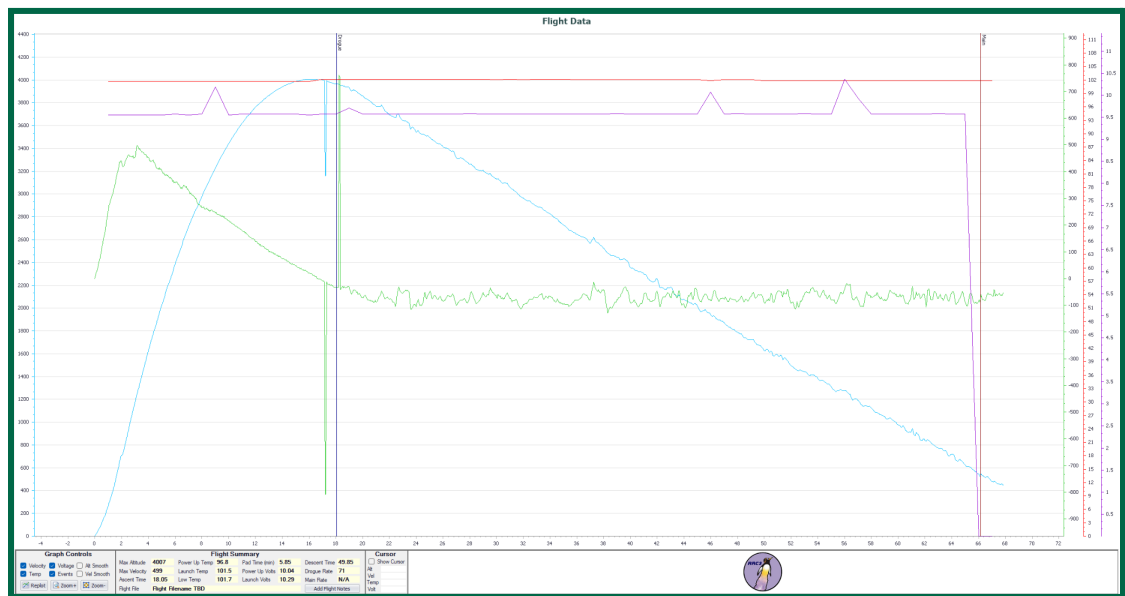
Fig. 5: Launch 1 flight graph from backup Missileworks RRC3

The main altimeter did not record data from the first flight for some reason. The main altimeter did deploy the black powder charges for the first flight. This has led SOAR to believe that the hard landing of the avionics bay may have led the main altimeter to lose that data due to a faulty connection.

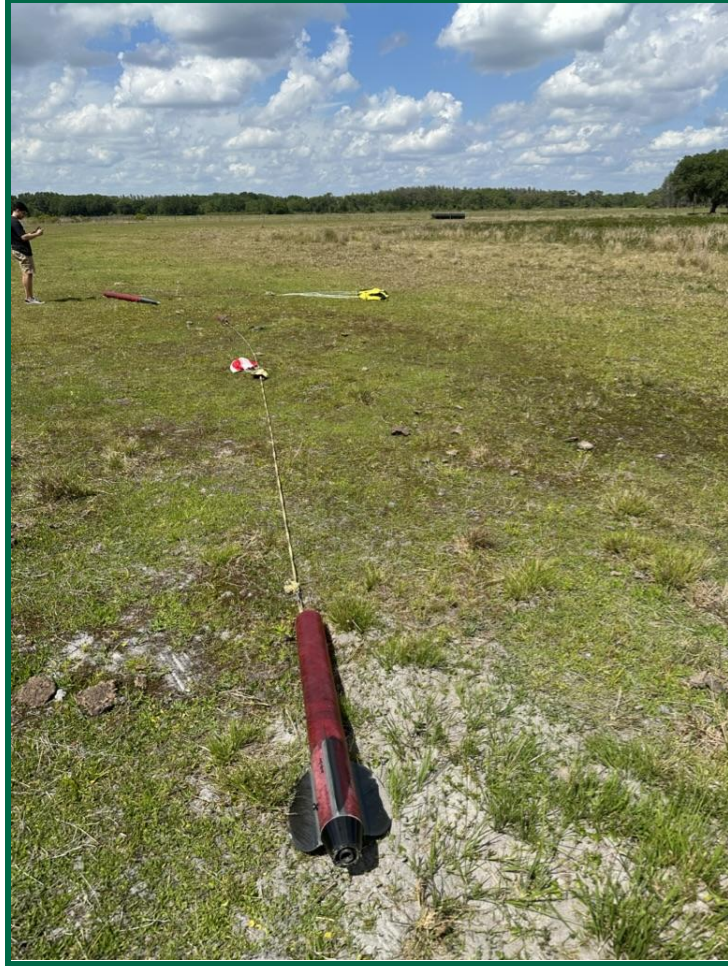
Fig. 11: Launch 1 landing of rocket

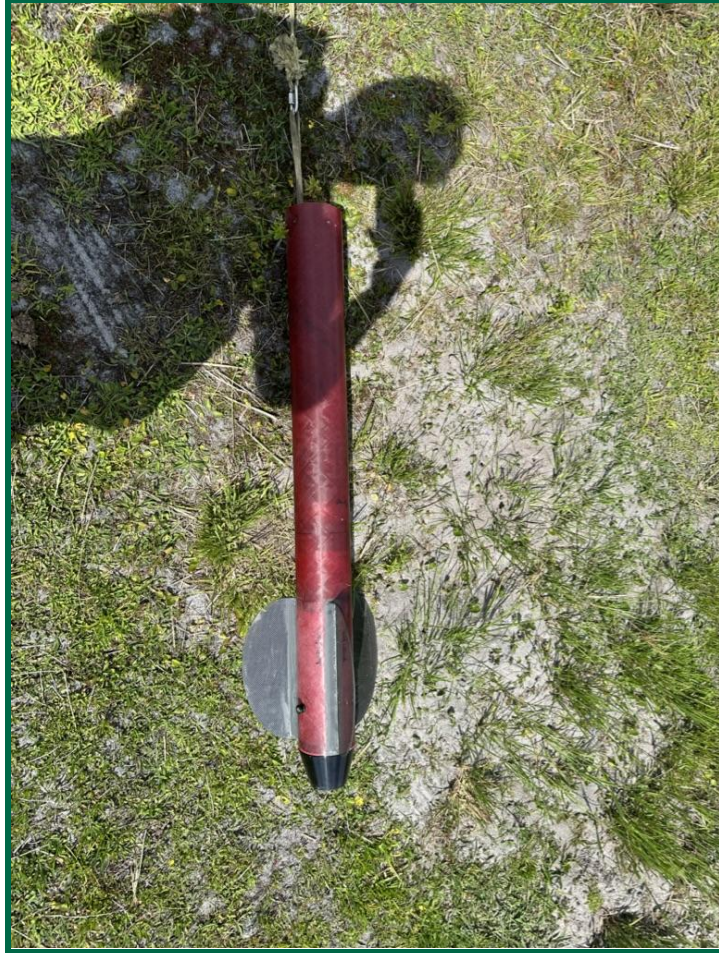
Fig. 12: Launch 1 Booster Tube

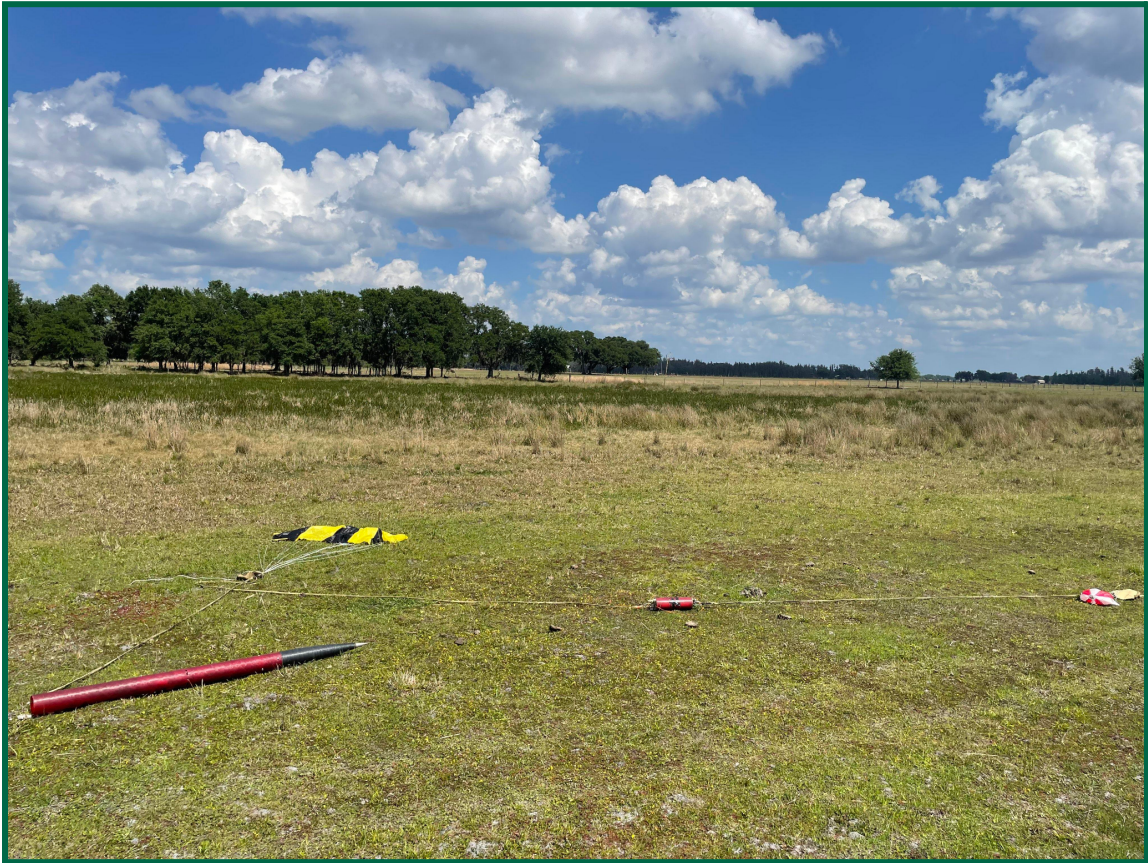
Fig. 13: Launch 1 Upper Tube and avionics bay

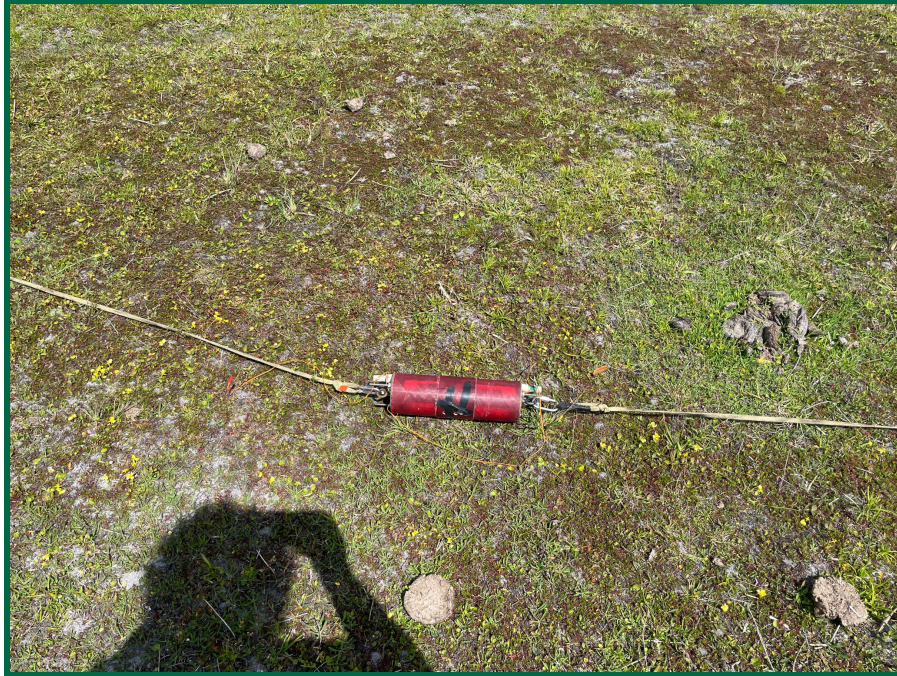
The main altimeter did not record data from the first flight for some reason. The main altimeter did deploy the black powder charges for the first flight. This has led SOAR to believe that the hard landing of the avionics bay may have led the main altimeter to lose that data due to a faulty connection.

Fig. 14: Launch 1 Avionics Bay

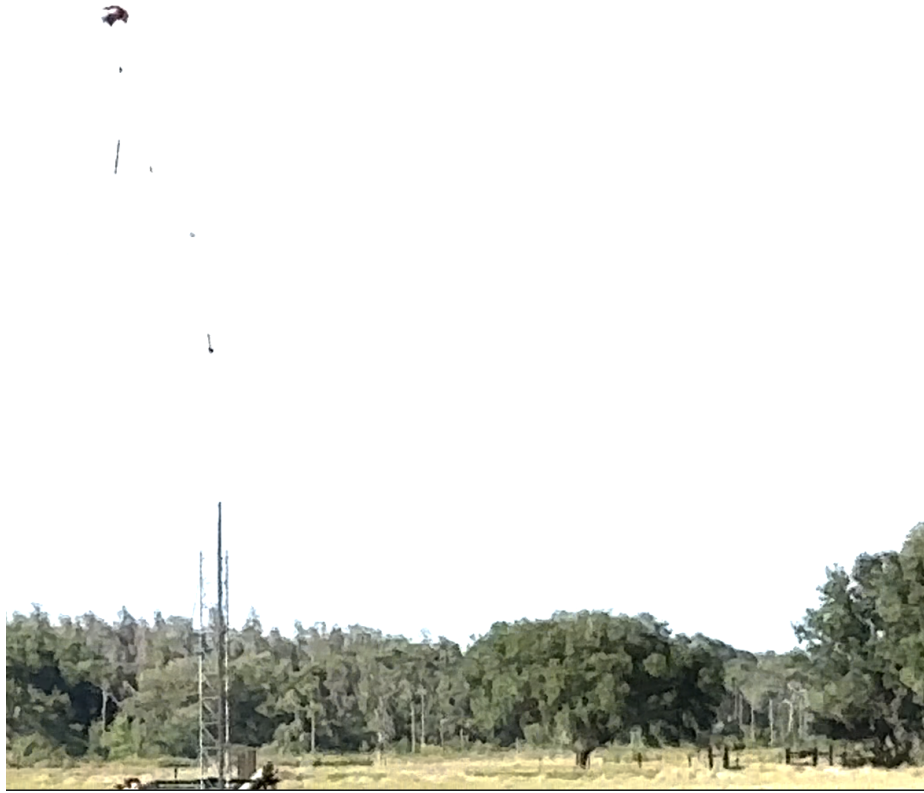
Fig. 15: Launch 2 Recovery Descent.

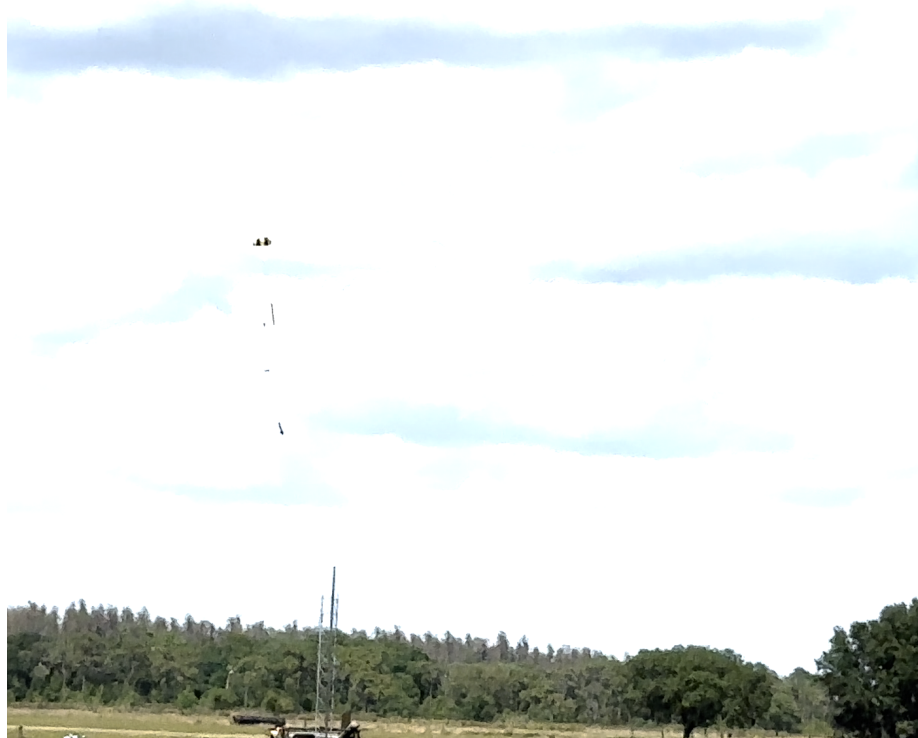
The main 60” parachute with a Cd of 2.2 for the first launch obtained holes near the center of the parachute and a shroud line was sheared off after flight.

To the surprise of the team, the new parachute had holes as well near the center. SOAR determined that the black powder charges lead to the holes in the parachutes as it was getting inside the nomex fire protectant.

Fig. 16: Launch 1 Recovery Descent

- The main parachutes must have more insulation to preserve the recovery system.

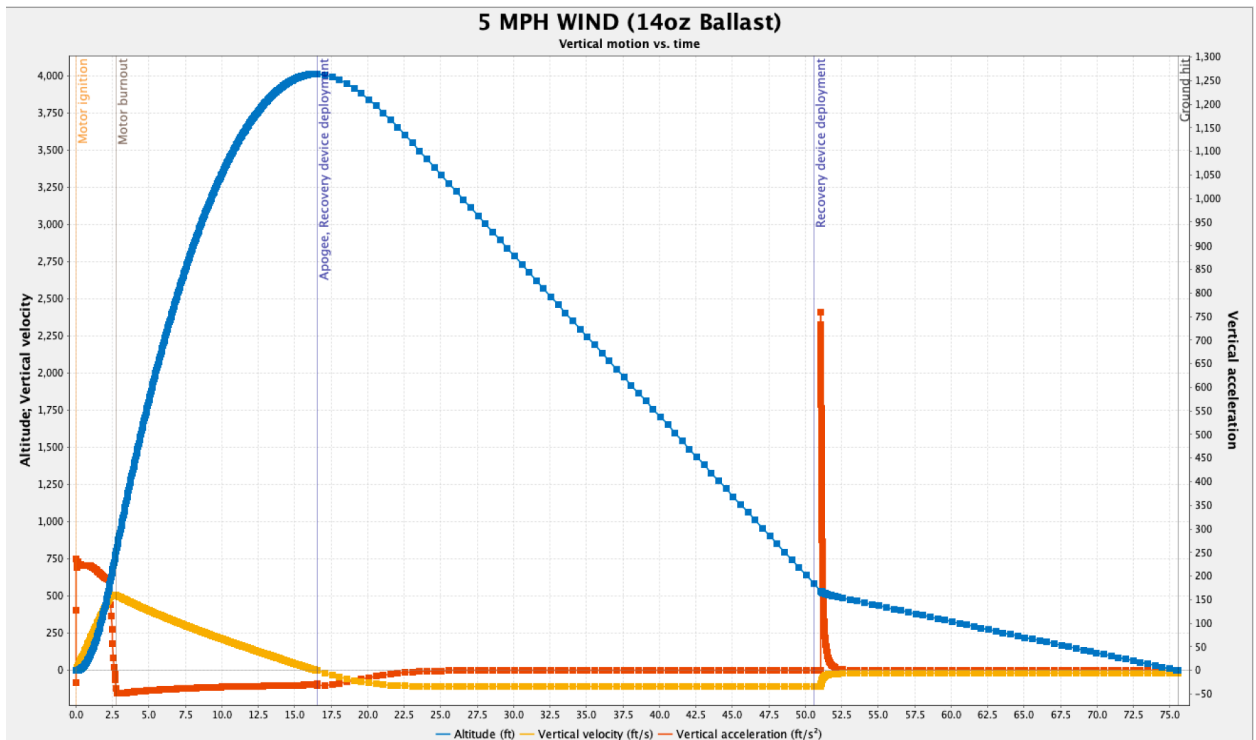
The results of the analysis is that the simulated flight model is similar to the flight performance at the launch day. The fine tuning of the wind values in the plotting section can always be improved by collecting more wind data with the anemometer during the launch day. All though the average wind speed was at 5 mph during the day, there was gusts of wind that reached up to 12 mph. This could have led to the changes in the apogee that we saw with the flight data.

Fig. 15: Simulated flight model with launch day conditions.

- Collect more wind data during the launch to refine simulated apogees and landing locations.
